NATIONAL PROGRAM FOR INSPECTION OF NON-FEDERAL DAMS
SPAULDING DAM (NH-003) (U) CORPS OF ENGINEERS WALTHAM
MA NEW ENGLAND DIV APR 79

PISCATAQUA RIVER BASIN
ROCHESTER, NEW HAMPSHIRE

SPAULDING DAM
NH-00390

PHASE I INSPECTION REPORT
NATIONAL DAM INSPECTION PROGRAM

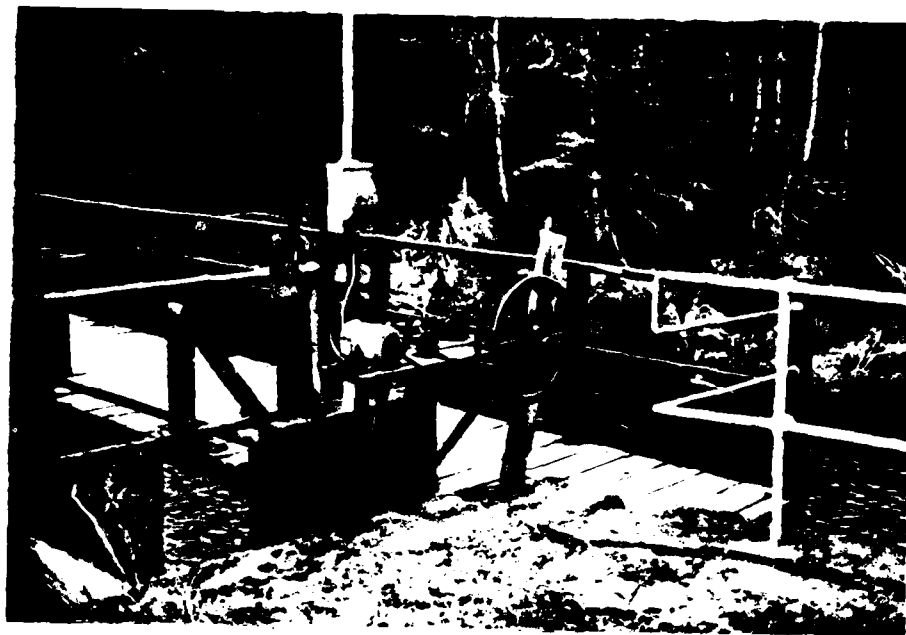
Stop logs and spillway gates appear to be in good repair. All hoisting equipment appears operable and in good condition, except the timber lift members of the controlled outlet mechanism which show signs of some rot. Maintenance of the equipment is on an as-needed basis.

1
HOISTING EQUIPMENT
REMOTE CONTROLLED GATE

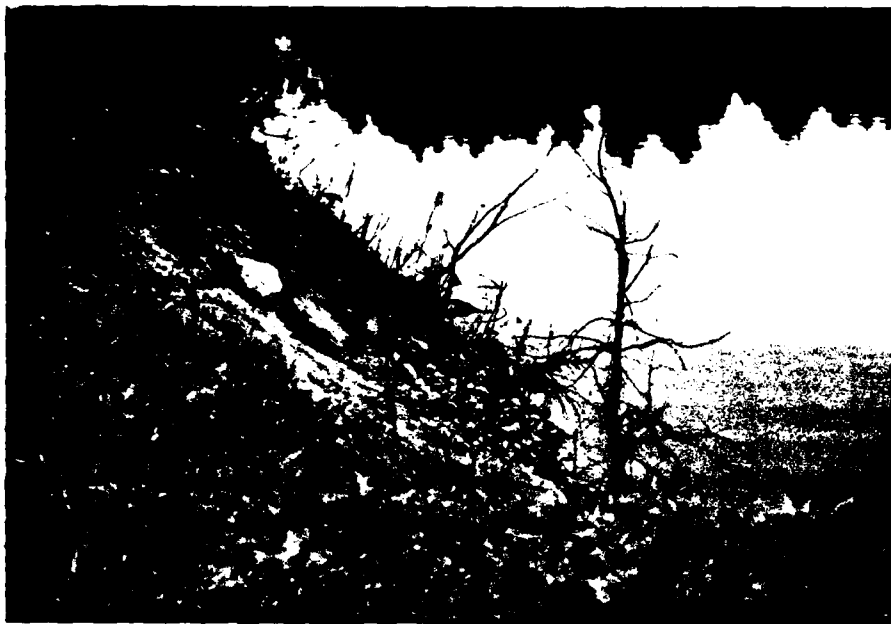
3

- (b) The crest of the north embankment and the slopes of both embankments are wooded. Ground cover consists of forest duff and bushes. Substantial erosion has occurred on the upstream face of the south embankment in an area located about 30 feet south of the spillway (see Photo 3). Some erosion was noted on the

ERODED AREA ON UPSTREAM FACE
OF SOUTH EMBANKMENT,
NEAR POND DRAIN OPERATING
EQUIPMENT.

The embankment portions of the dam should be repaired where eroded, raised to a uniform elevation with appropriate materials, and riprapped and/or turfed with an erosion resistant vegetative cover. A program of complete or selective cutting of trees from the embankments and preservation of stumps with subsequent monitoring for deterioration should be investigated and implemented. This embankment repair should be done under the supervision of a qualified engineer.

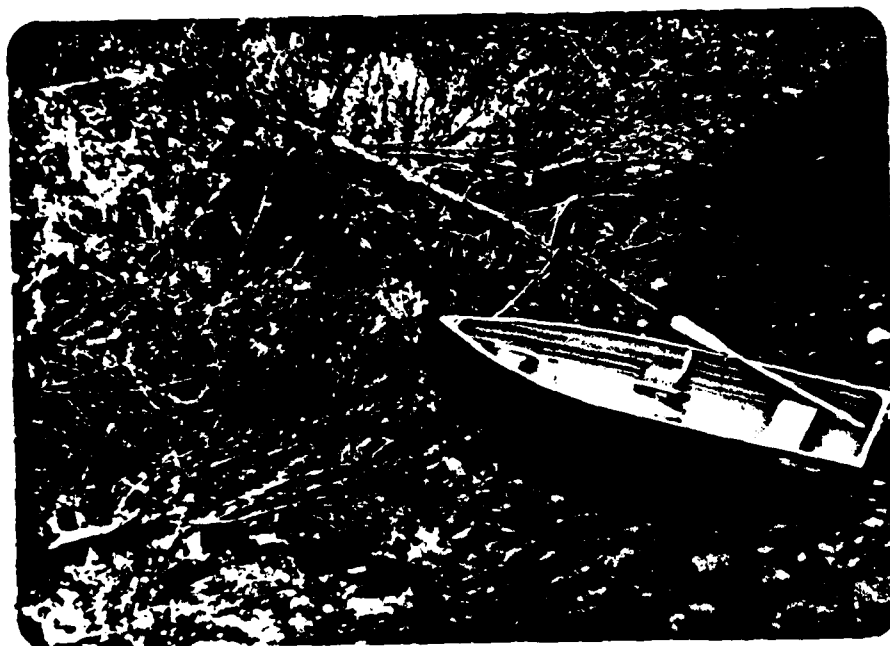
6

- (d) A large spring exists in the edge of the stream bank below the north abutment (see Photo 6). The flow from this spring was estimated to be at least 50 gpm. Erosion and local sloughing of the stream bank have occurred in the area of the spring. Several smaller springs were also observed along the north stream bank downstream of this area.

IRON SPRING ON NORTH STREAM BANK
BELOW NORTH ABUTMENT OF SPILLWAY

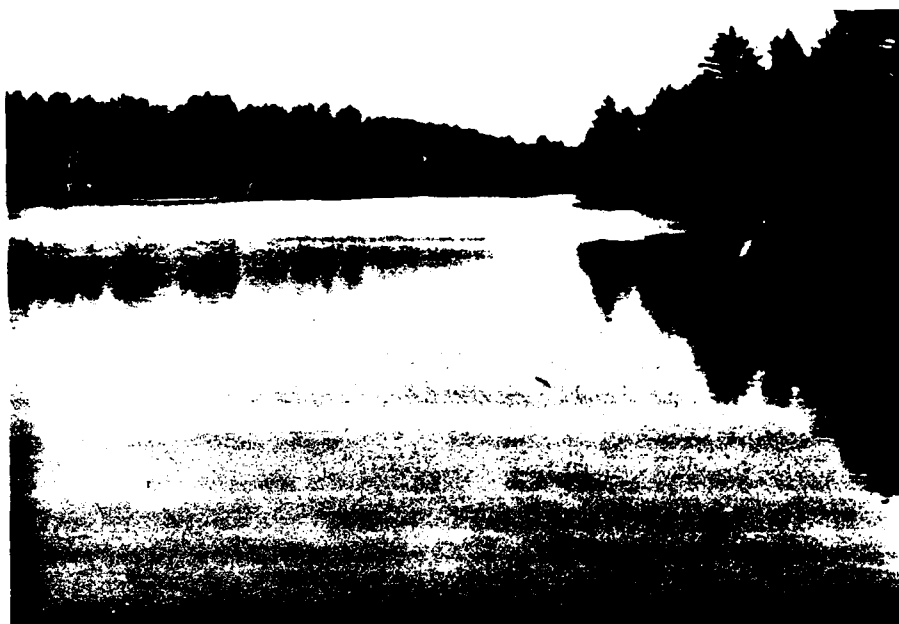
d. Reservoir Area. The reservoir consists of a pond of about 112 acres which has a forested shoreline (see Photo 7). No residences were observed on the shores of the pond. The potential for slope failure upstream from the dam appears minimal.

7
VIEW UPSTREAM FROM SERVICE BRIDGE

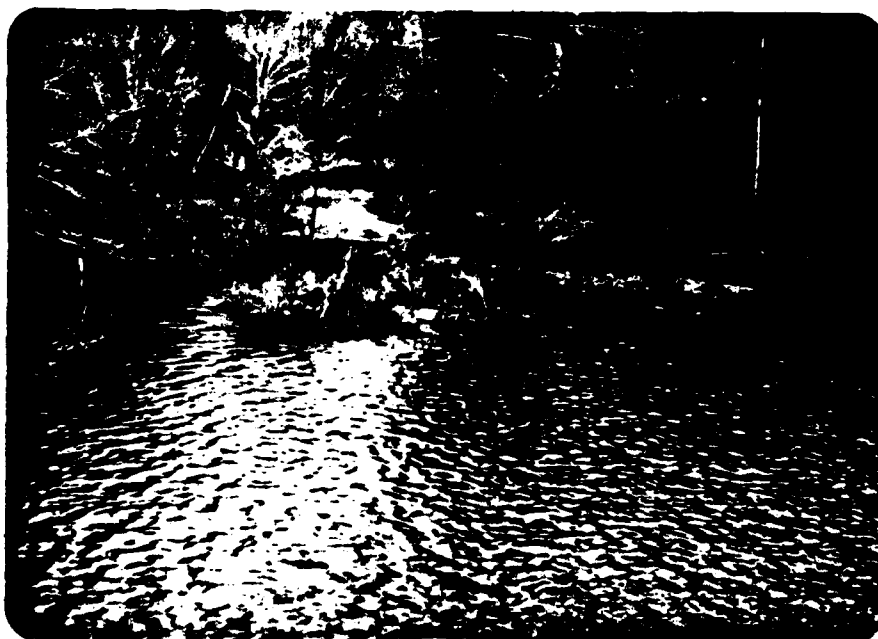
8
VIEW DOWNSTREAM FROM SERVICE BRIDGE

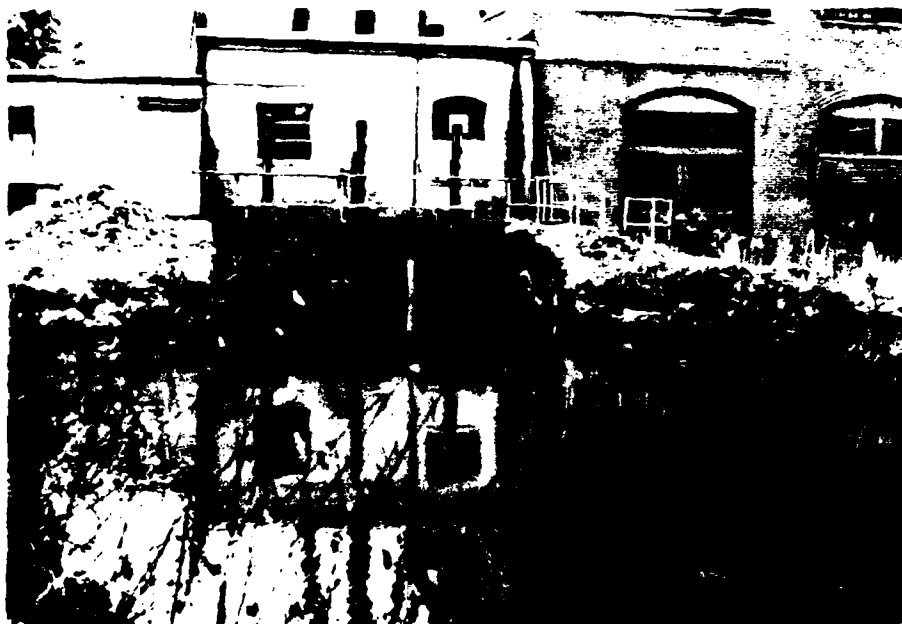
9

SERVICE OUTLET TO POWERHOUSE AT
SPAULDING FIBRE CO. MILL
